BEAVER LAKE DAM

PHASE I INSPECTION REPORT

NATIONAL DAM INSPECTION PROGRAM

(6) National Dam Inspection Program.
Beaver Lake Dam (NDS I.D.
Number PA-354, DER I.D. Number
41-10), Beaver Lake Enterprises,
Susquehanna River Basin, Beaver
Run, Lycoming County, Pennsylvania.
Phase I Inspection Report,

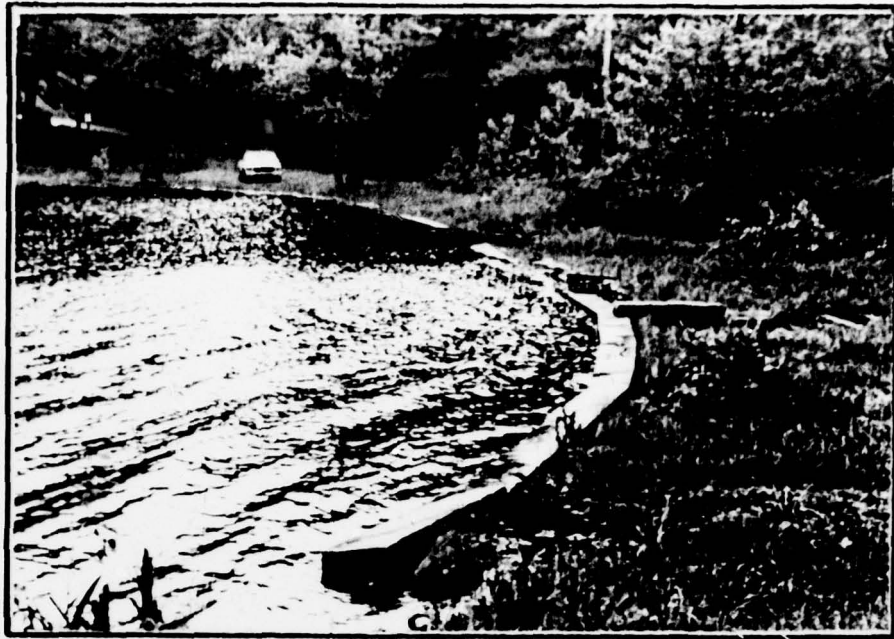
Concrete wall from right end of dam.

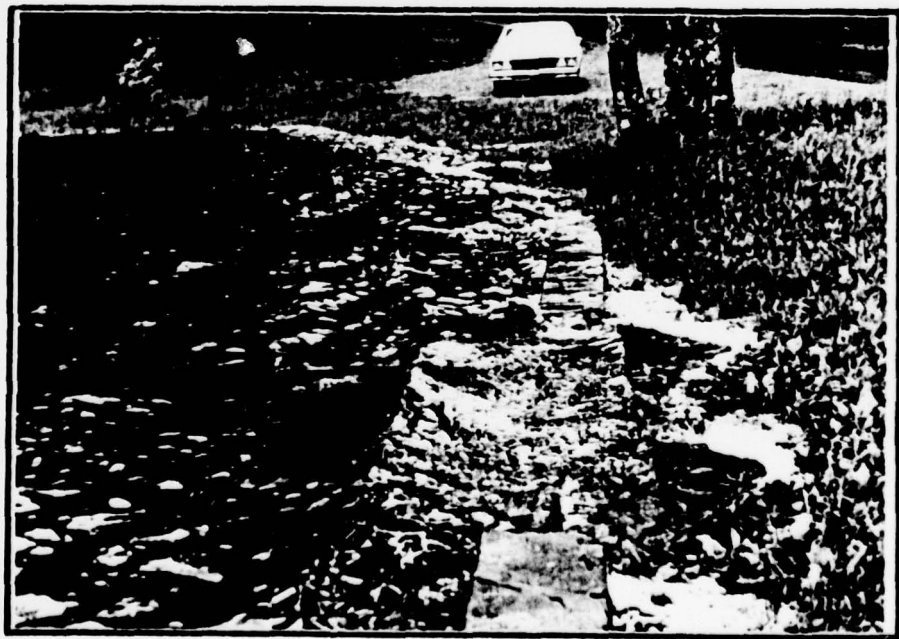
b. Dam. The dam is in very poor condition. The concrete wall on the upstream slope is broken, cracked, deteriorated and leaning. Part of the wall to the left of the spillway has been washed out (See page A-13). To the right of the spillway most of the wall is leaning and may fail. The stone wall forming the downstream slope is in fair condition. Near the left abutment are several large trees growing on the dam. Near station 3 + 05 water is seeping through or under the concrete wall and up onto the embankment crest. The water is then flowing over the crest and down through a hole in the embankment and eventually through the stone wall. The crest varies from elevation 899.8 to 900.2. Water level at the time of inspection was at elevation 899.7. Wave action was carrying water over the crest. In addition, a breach in the spillway left wall was carrying more water over the embankment to the left of the spillway than through the spillway.

Concrete wall to the left of spillway.
Note no freeboard.

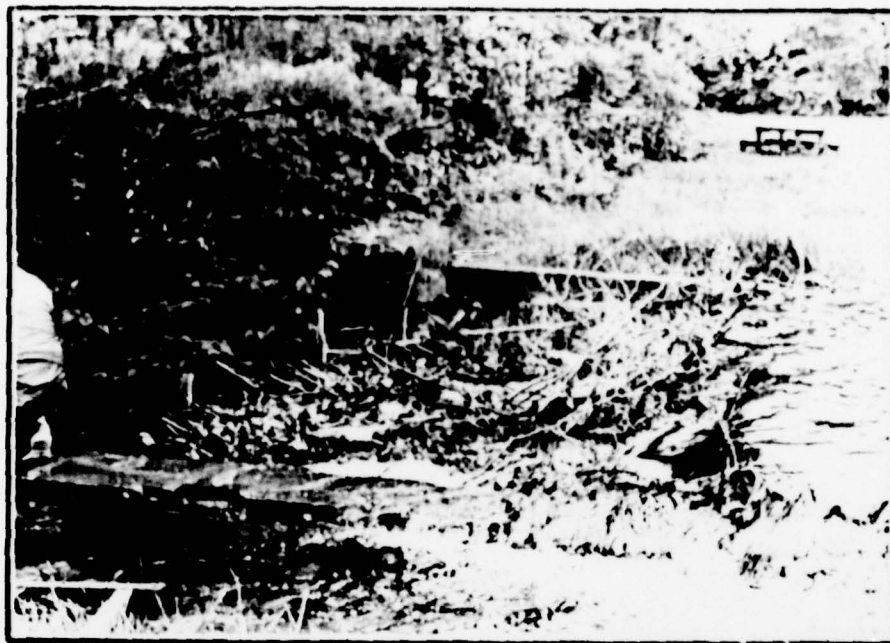
Debris blocking spillway.

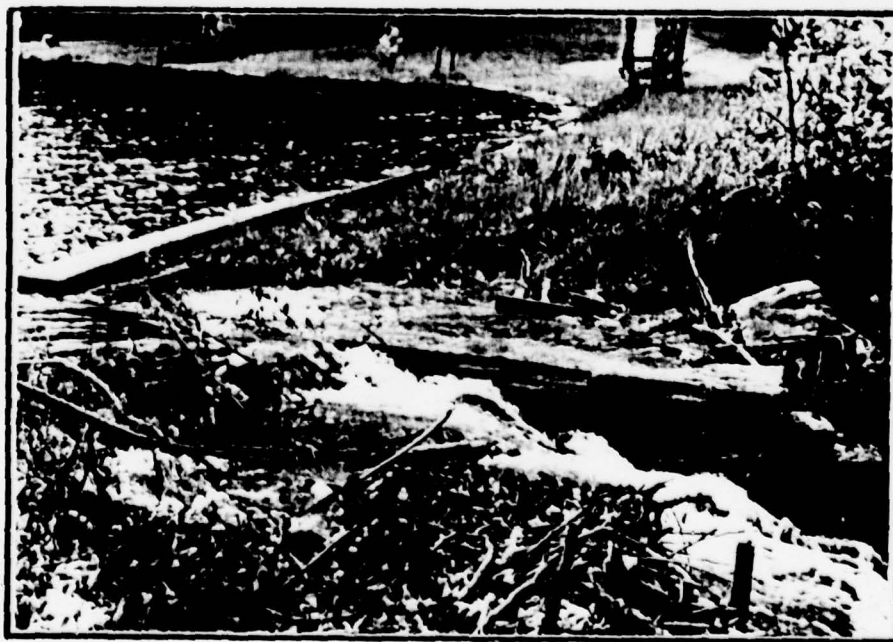
Debris blocking spillway and water flowing around spillway.

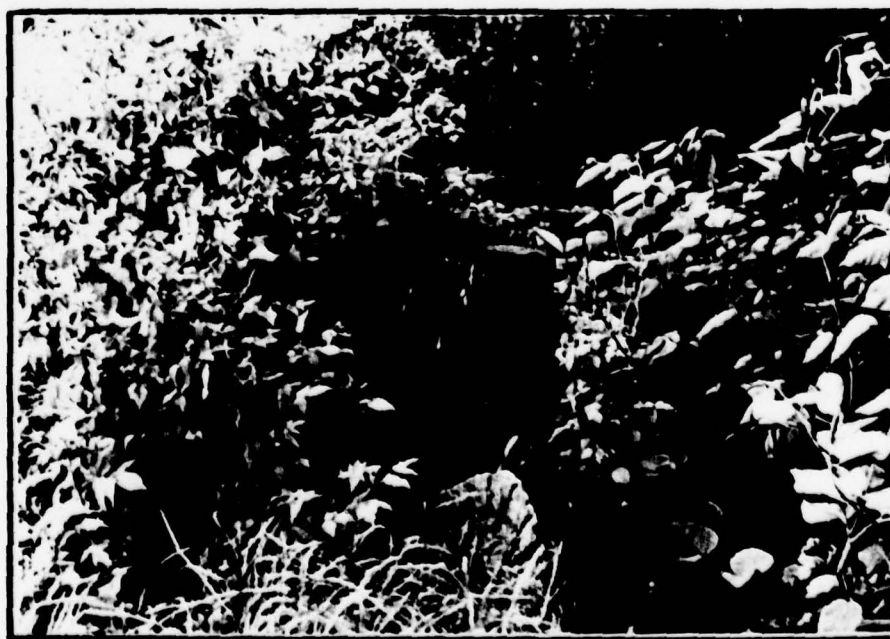
Stump on embankment at stone wall.
